# Manhole Inspection Summary

Manhole # S41U\_\_014MH

**Location** Address: **rear 1022 e fort av**

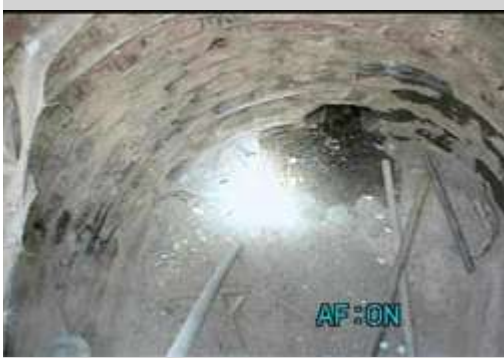
Defect 2

Condition: ☐ Sound ☐ Cracked ☐ Root Intrusion ☐ Deteriorated ☐ Leaks ☒ **Debris**

channel debris

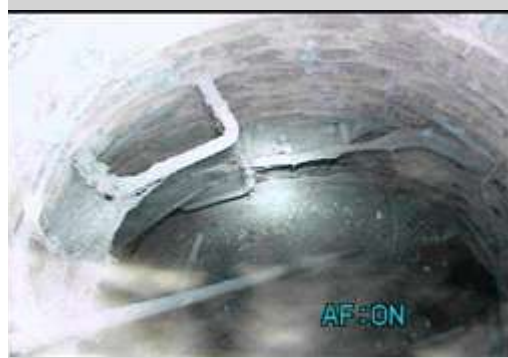
Defect 1

**Steps** Count: **3** Missing: **0** ☒ **Corroded**

corr steps

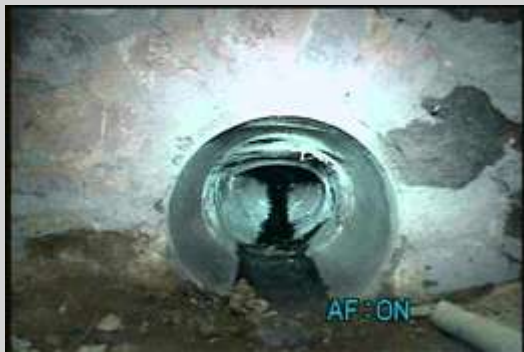
12 O'Clock Outflow

8 in. Circular Gravity Sewer  
Pipe Out @ 12 O'Clock

Pipe Material: **Clay** ☐ Pipe Lined

Invert Depth: **6.00** (ft.) Flow Characteristics: **None**

Deposits: ☒ None ☐ Mud ☐ Sludge ☐ Debris ☐ Grease

Infiltration: **None** Pipe Seal Cond: **Unknown**
